AL HILLAH POLICE FIRING RANGE
AL HILLAH, IRAQ

SIGIR PA-06-076
JANUARY 08, 2007

SUBJECT: Report on Project Assessment of the Al Hillah Police Firing Range,
Al Hillah, Iraq (Report Number SIGIR-PA-06-076)

Al Hillah Police Firing Range, Al Hillah, Iraq

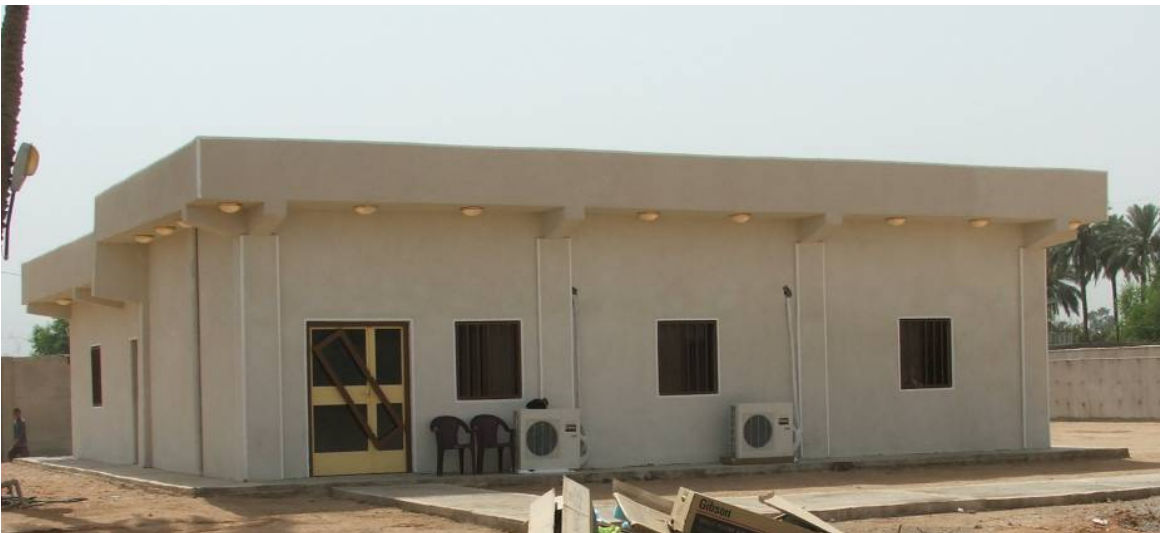
We inspected each room of the building (Site Photo 1) as well as the exterior and the roof. The building's exterior walls were plastered, textured, and painted. A concrete walkway was constructed around the perimeter in accordance with the design.

Site Photo 1. Range control building

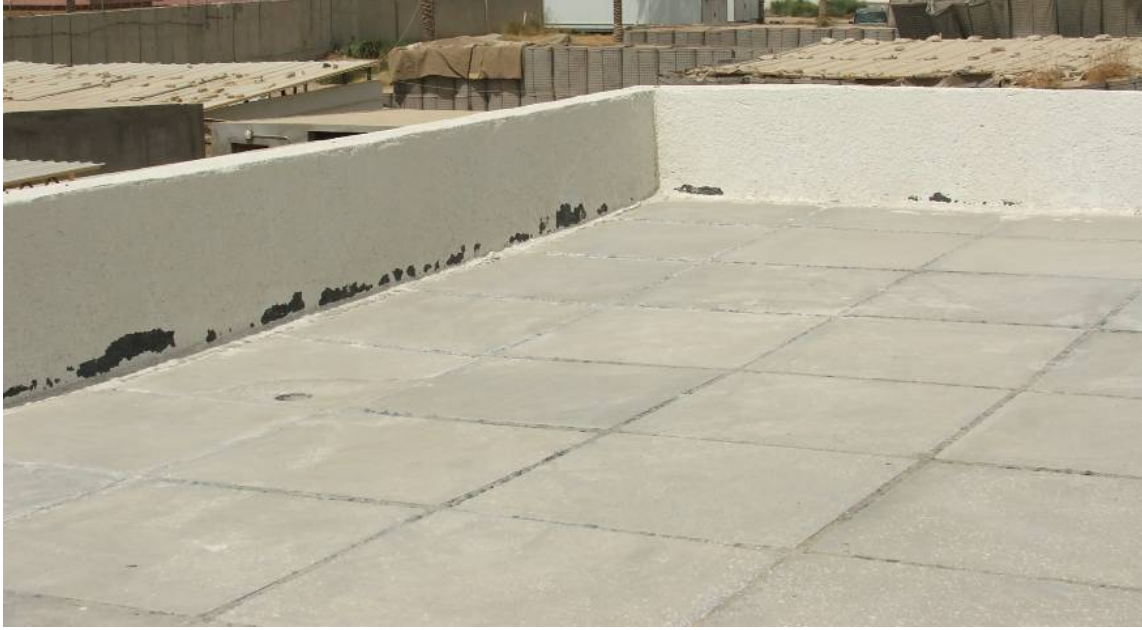
The roof construction consisted of concrete tiles and mastic joints, and a plastered and textured parapet. Site Photo 2 shows the roof. The roof appeared adequately constructed, although we did notice a portion of the finish coat of paint peeling away from the interior of the parapet wall.

Site Photo 2. Range control building roof

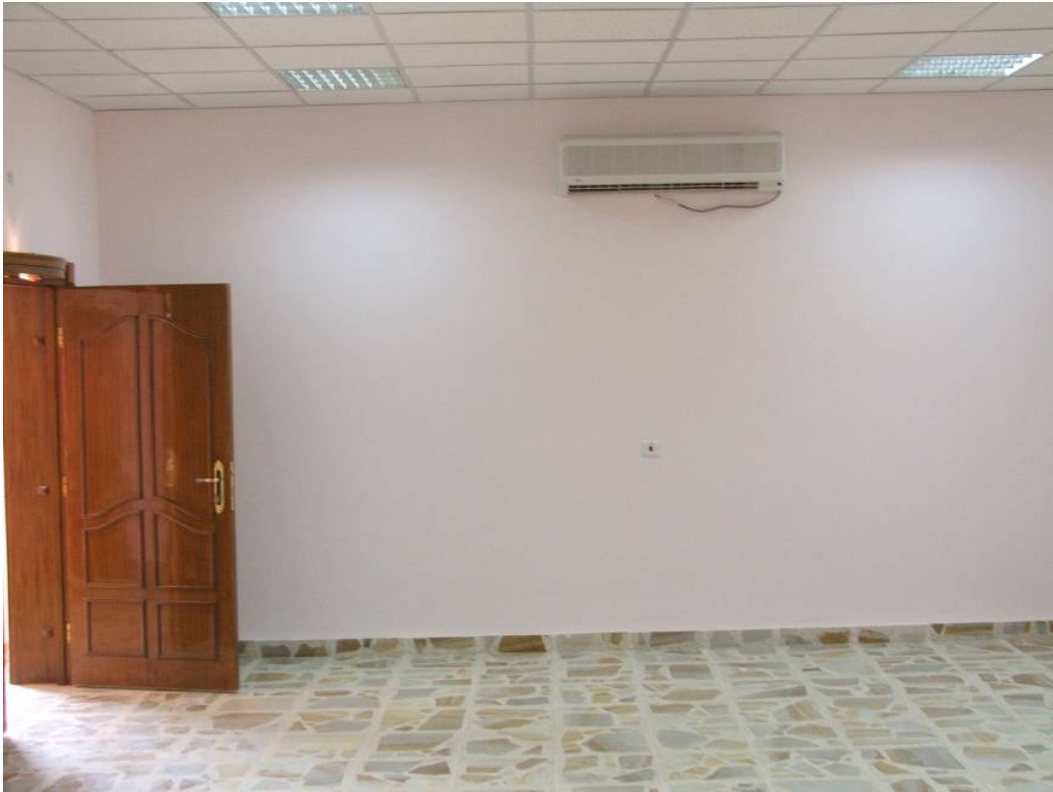
In summary, we did not observe any significant deficiencies with the range control building construction. Site Photos 3-5 provide examples of the features in the building observed during our inspection.

Site Photo 3. Range control building waiting room

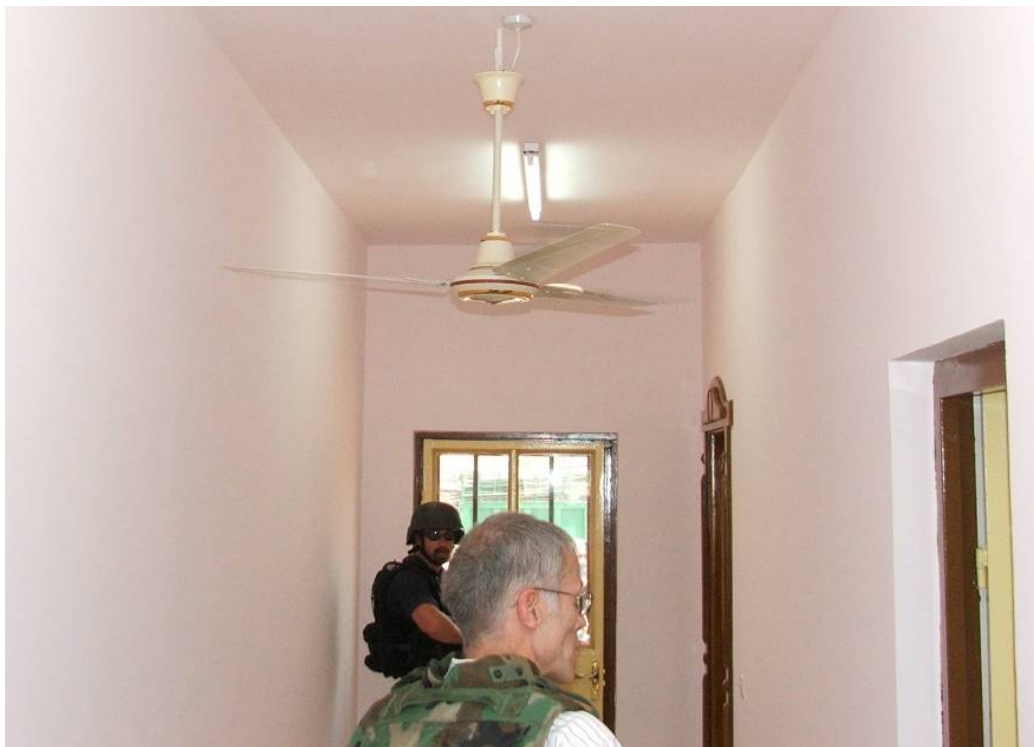
Site Photo 4. Hallway in range control building

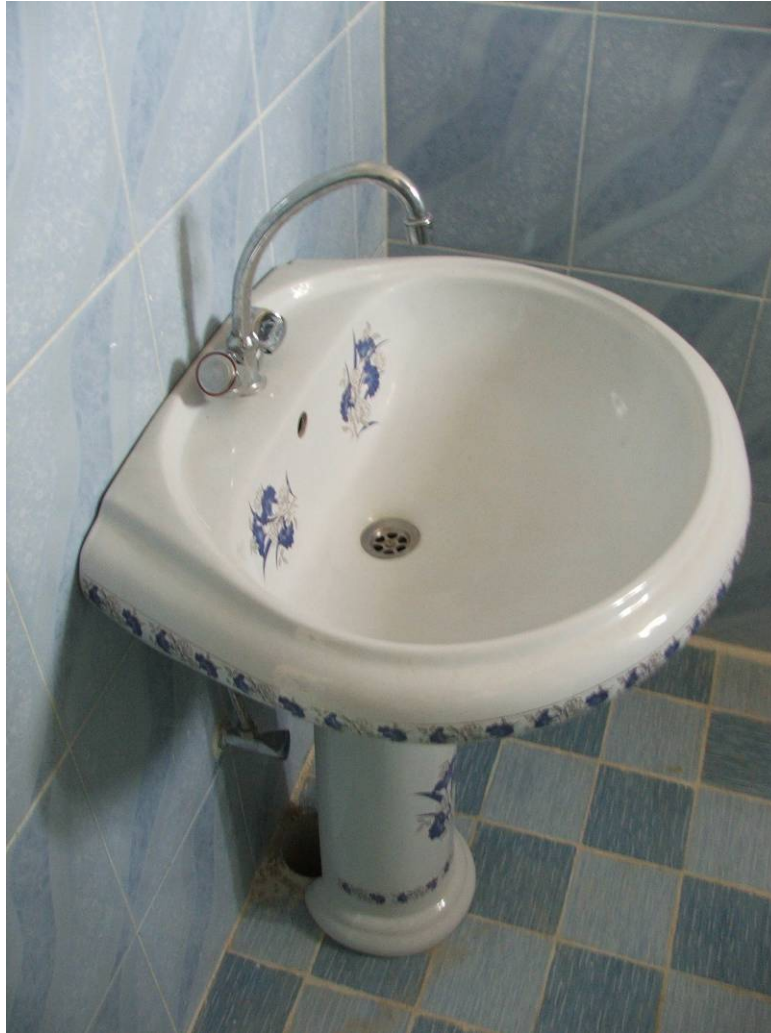
Site Photo 5. Wash basin and tile work in one of the range control building bathrooms

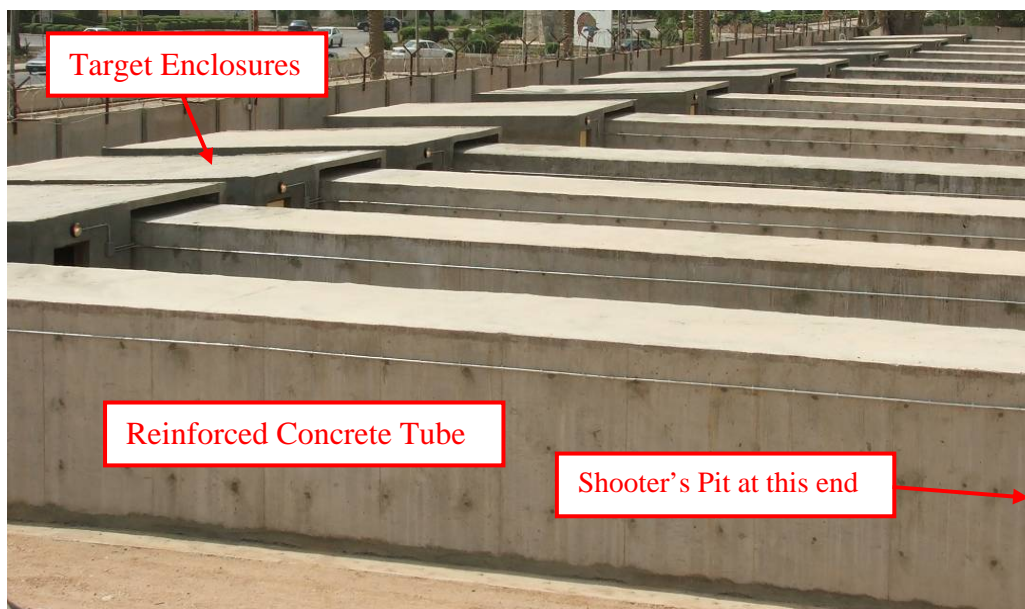
The design for the rifle firing tubes shown in Site Photos 6, 7, and 8 called for a reinforced concrete tube, 25 m in length. The target was housed in an enclosure constructed with grout filled masonry sidewalls and a reinforced concrete back wall and cover. The 2 m wide by 2.1 m high firing tube was designed with reinforced concrete side walls, floor, and cover, each 10 centimeters (cm) thick.

Site Photo 6. Rifle firing tubes

Overall, we did not observe noticeable deficiencies associated with the rifle firing tubes. We also verified the dimensions of the rifle firing tubes, which were in accordance with the design requirements.

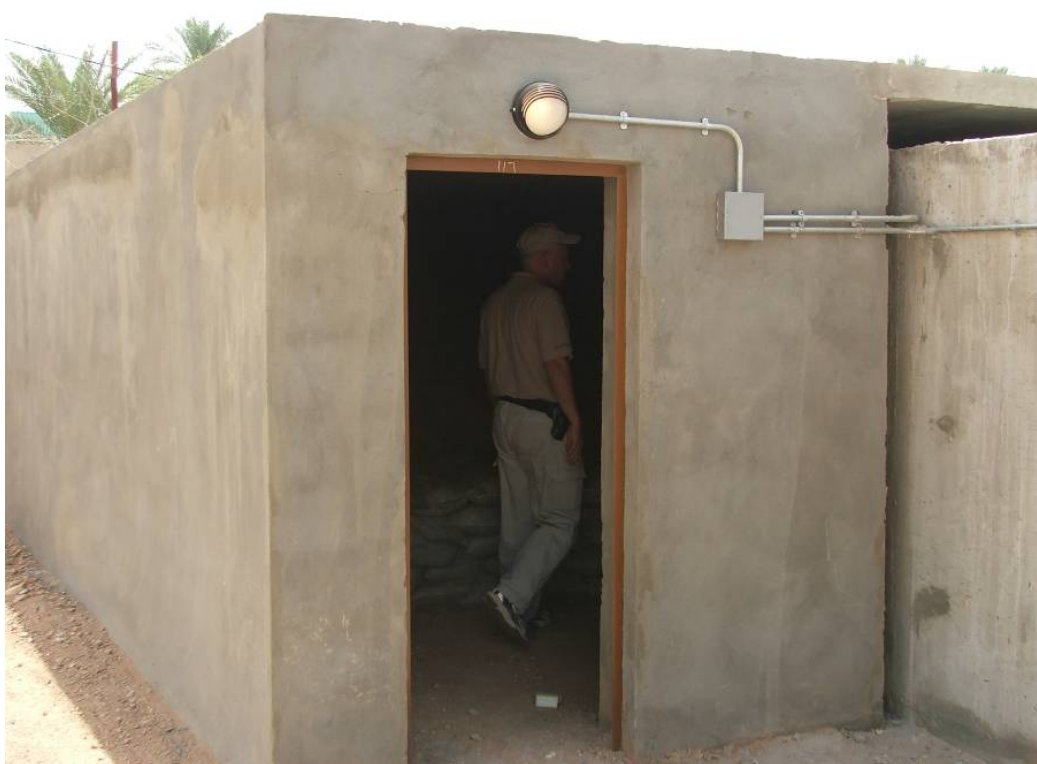
Site Photo 7. Target enclosure entrance

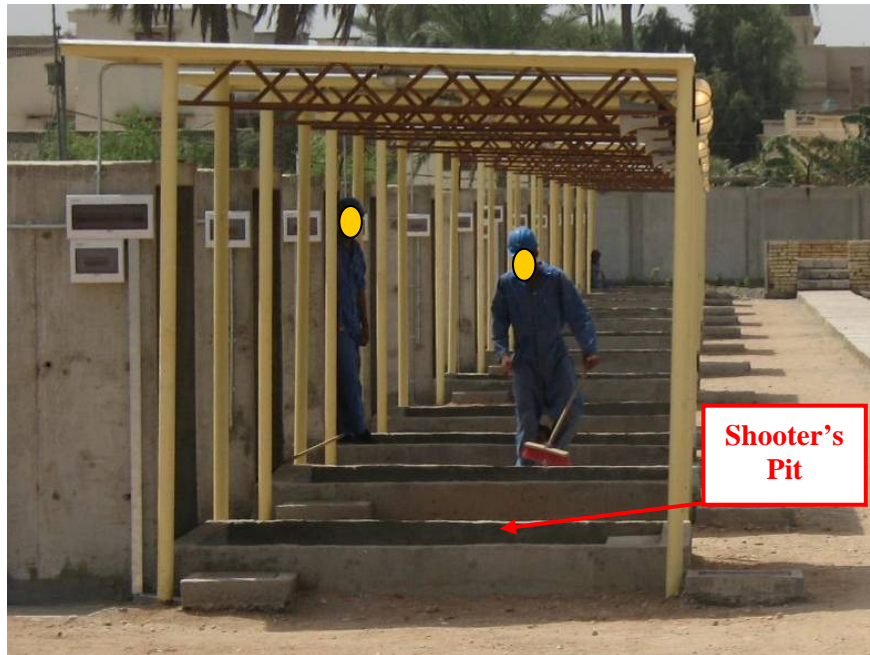
Site Photo 8. Shooter's pit at rifle firing tubes

The reinforced concrete shooter's pit at the end of the firing tube was below grade so that the pit floor was 0.75 m below the floor of the firing tube. The outside dimensions of the pit were 2 m wide by 3 m long, and the pit was covered with a metal cover supported by truss frame and four steel posts. The shooter's pit contained an overhead fluorescent light fixture as well as an exterior light mounted to the outside of the metal cover frame.

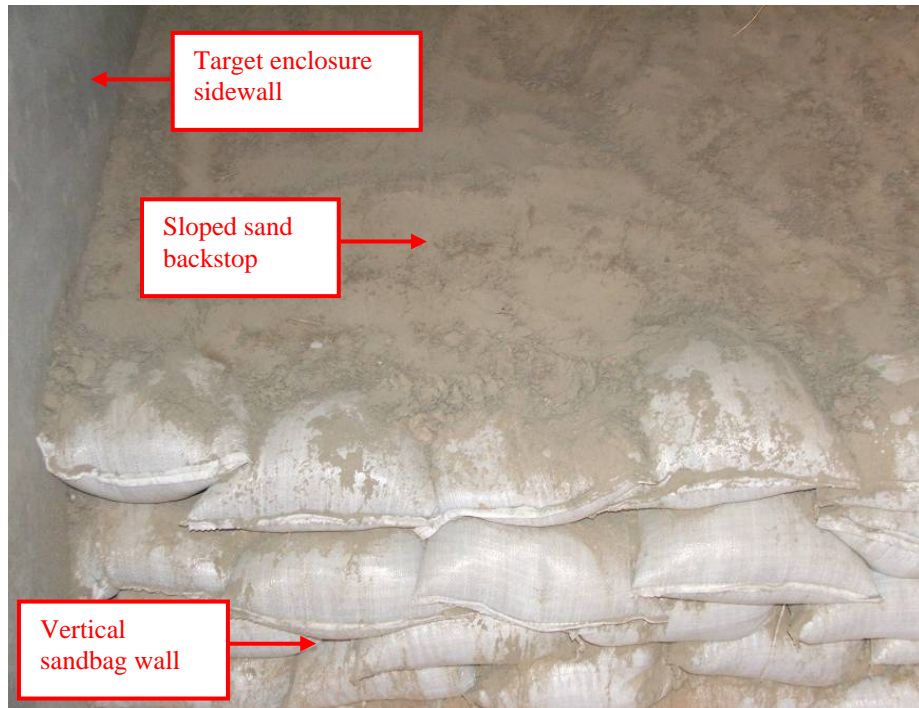
The target area was also illuminated with a spotlight positioned to light up the target area. The design also called for a sloped sand backstop behind the target. Based on the design, the sand backstop consisted of sandbags with a loose sand cover, and sloped at a 35 degree angle from the floor slab to the back wall of the target enclosure.

The actual constructed backstops were built in a slightly different manner. Instead of starting the backstop slope from the floor slab, the contractor had raised the toe of the slope by constructing a short vertical sandbag wall about 2 feet high. The sloped portion of the backstop wall started at the top of this sandbag wall and continued to the target enclosure back wall. Site Photo 9 shows the backstop in one of the target enclosures. We found the backstops adequately constructed, although there may be an issue with the stability of the two foot vertical sandbag walls when filled with bullet holes.

Site Photo 9. Backstop behind target

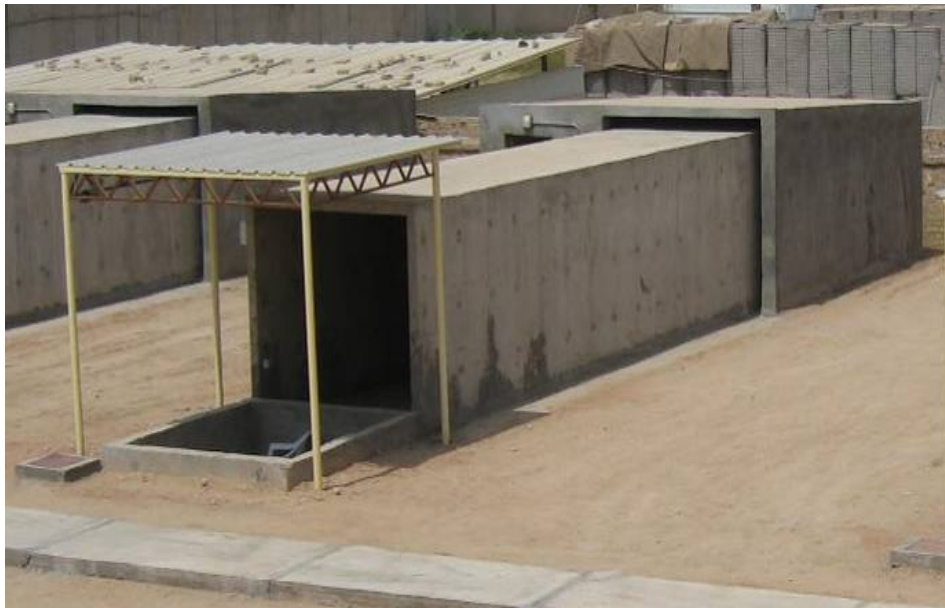
The design for the pistol firing tubes was similar to the rifle firing tubes except the reinforced concrete tube length was 10 m. Site Photo 10 shows one of the 12 pistol firing tubes. During our inspection, we verified the correct dimensions associated with the pistol firing tubes. The construction appeared to meet contract requirements.

Site Photo 10. One of the 12 pistol firing tubes

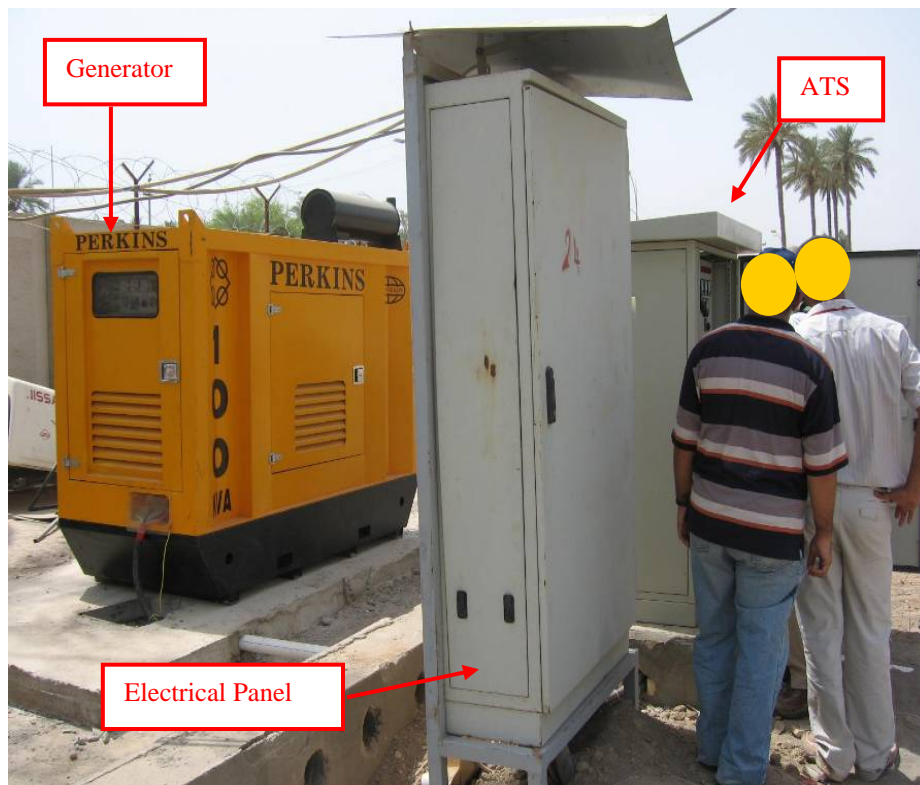
Site Photo 11 shows the 100 kVA generator installed on the concrete slab, the electrical panel, and the automatic transfer switch (ATS). The generator cover and the external fuel tank were not yet installed.

Site Photo 11. Generator, electrical panel, and automatic transfer switch (ATS)

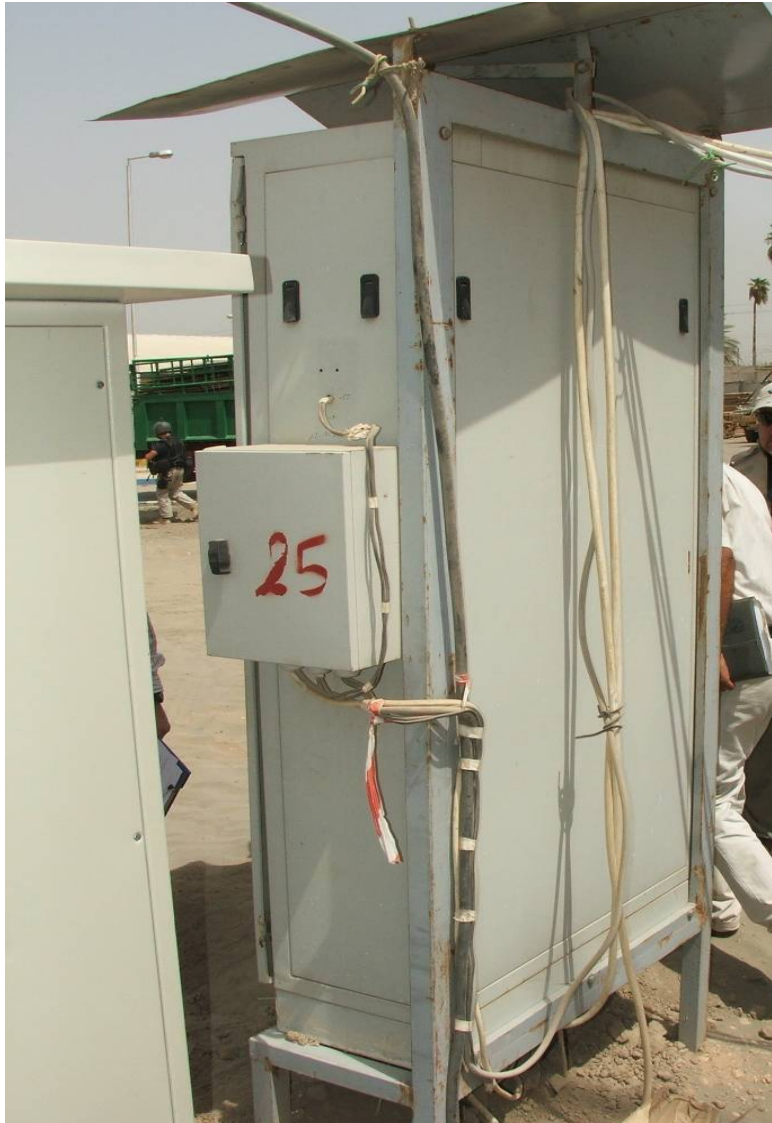
On the rear side of the electrical panel shown in Site Photo 12, we found some portions of the metal frame rusted. Additionally, the cable connecting the ATS to the panel was not enclosed in rigid conduit.

Site Photo 12. Rear side of electrical panel
